**Amendment 39-17254; AD 2012-10-53]**

**Airworthiness Directives; Eurocopter Deutschland GmbH Helicopters**

2012-10-53 **EUROCOPTER DEUTSCHLAND GMBH (ECD)**: Amendment 39-17254; Docket No. FAA-2012-1188; Directorate Identifier 2012-SW-049-AD.

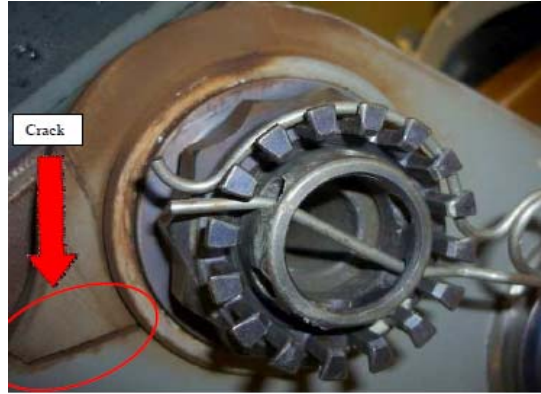
Figure 1 to Paragraph (f)(1)

(1) Before further flight, and thereafter at intervals not to exceed 6 hours time-in-service (TIS), check the MRH shaft lower flange and the visible area of the MRH shaft upper flange for a crack. Figures 1 and 2 to Paragraph (f)(1) of this AD are examples of cracks that have been discovered in the MRH shaft lower flange. The actions required by this paragraph may be performed by the owner/operator (pilot) holding at least a private pilot certificate, and must be entered into the aircraft records showing compliance with this AD in accordance with 14 CFR §§ 43.9 (a)(1)-(4) and 14 CFR § 91.417(a)(2)(v). The record must be maintained as required by 14 CFR §§ 91.417, 121.380, or 135.439.

(3) If there is a crack in the upper or lower MRH shaft flange, before further flight, replace the MRH shaft. Replacing the MRH shaft with an MRH shaft having a part number listed in the applicability of this AD does not constitute terminating action for the requirements of this AD.

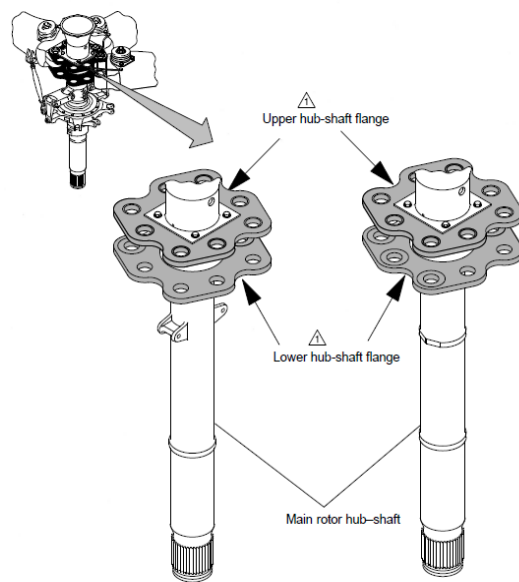
(ii) Clean the upper and lower MRH shaft flange as depicted in Figure 3 to Paragraph (f)(2)(ii) of this AD and visually inspect for a crack.

⚠ Check visible area of the upper and lower hub-shaft flange.

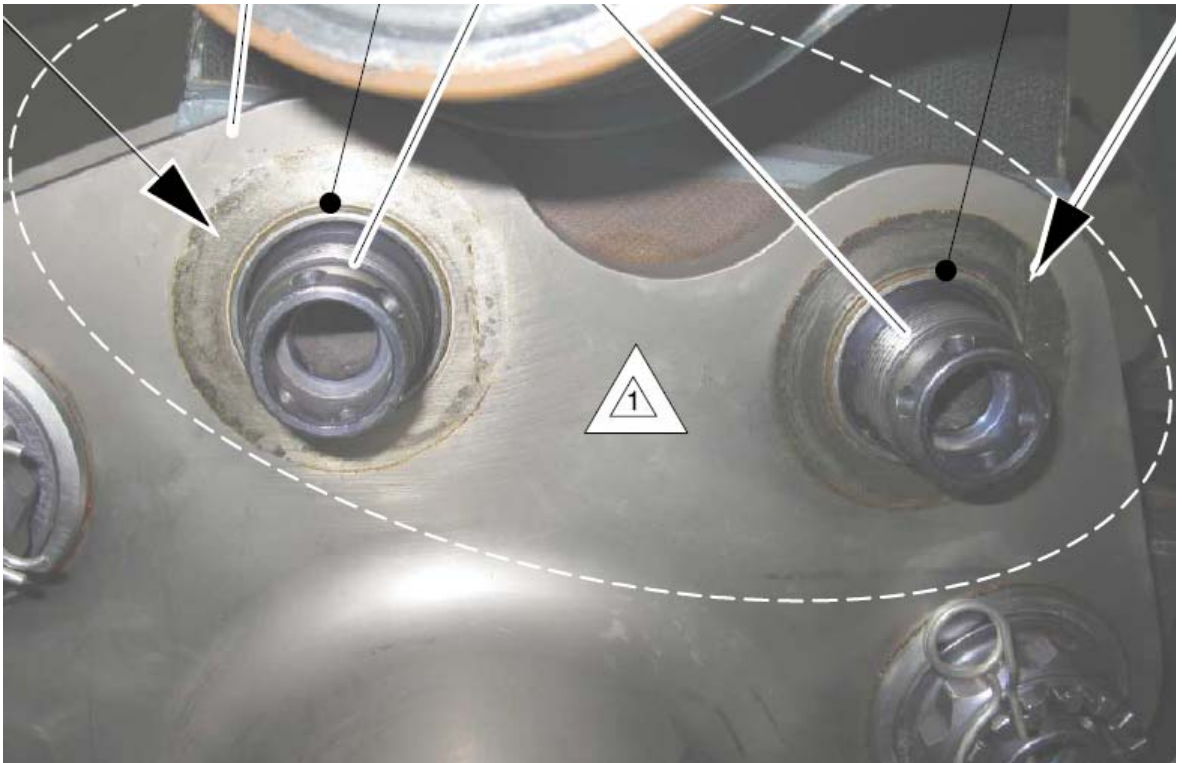
(v) Using a 10X or higher power magnification, inspect all lower MRH shaft flange blade bolt attachment areas for a crack as shown in Figure 4 to Paragraph (f)(2)(v) of this AD.
